# Horsea Island Second World War Landing Craft Slipways Portsmouth, Hampshire

Research Report Series no. 177/2020

# Horsea Island Second World War Landing Craft Slipways Horsea Island, Portsmouth Hampshire

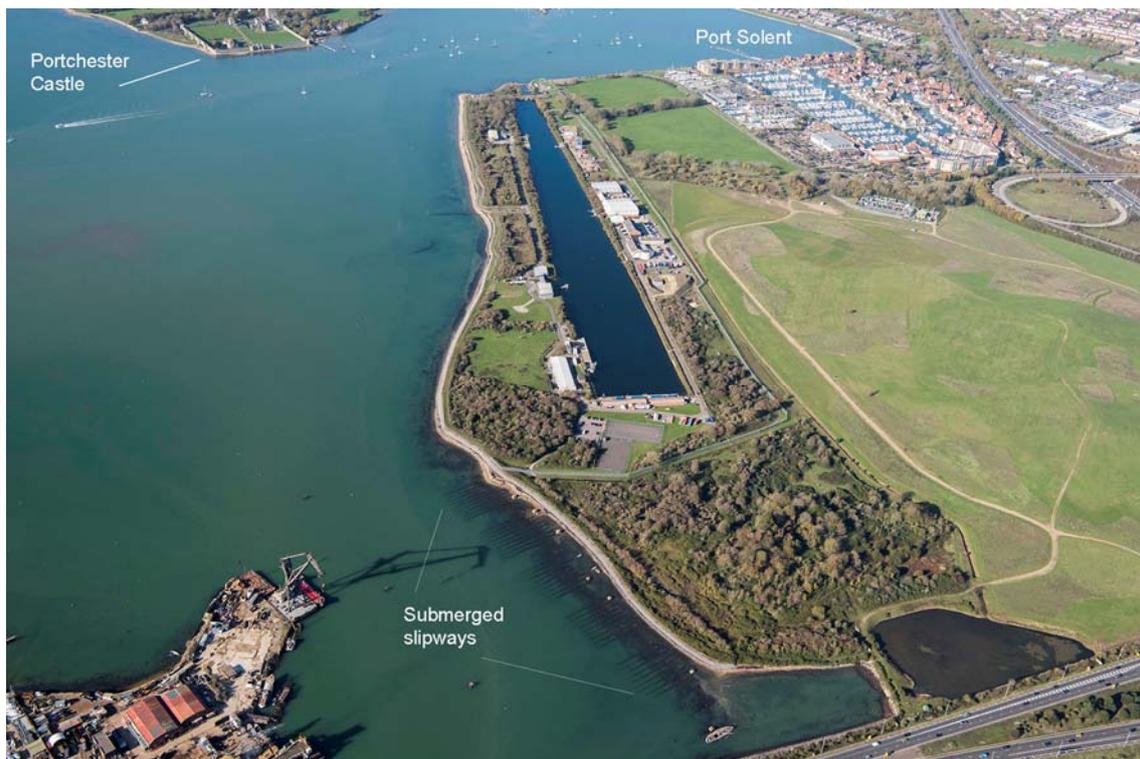
Figure 1: Horsea Island viewed from the south-east down the length of the former torpedo testing pond with Portsmouth Harbour and Portchester Castle beyond. The remains of the slipways are submerged by the tide in this view, visible as a dark smudge in the water along the beach in the foreground HEA 33943\_013 04-NOV-2020 © Historic England Archive.

A line of four free-standing mooring dolphins can be seen to the south in the deeper water (Fig 12), for mooring and positioning the craft laterally before drawing them sideways onto the slipways on the rising tide. Once in position they were secured to the platforms on the slipways and hauled out of the water. Three of these mooring dolphins remain and are visible on aerial photographs taken in 2020 (Fig 1).

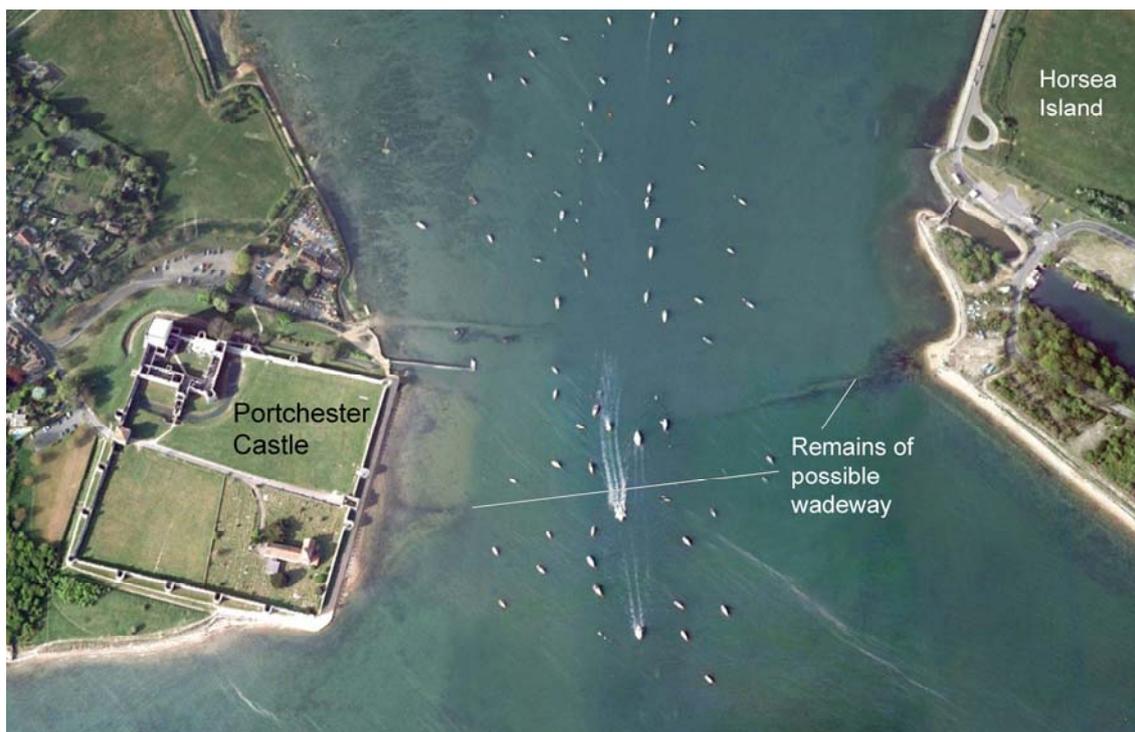
Figure 5: Aerial photograph showing the remains of the former wadeway between Horsea Island and Portchester Castle at high tide. EARTH.GOOGLE.COM 21-APR-2007 ACCESSED 04-Feb-2020.

There is a possible fourth wadeway between Little Horsea and Portchester Castle recorded on aerial photographs (Fig 5). Construction of a pier in the 1880s and 1890s along the course of the wadeway unearthed Roman remains suggesting the causeway could have early origins (Ripley 1982, 3).

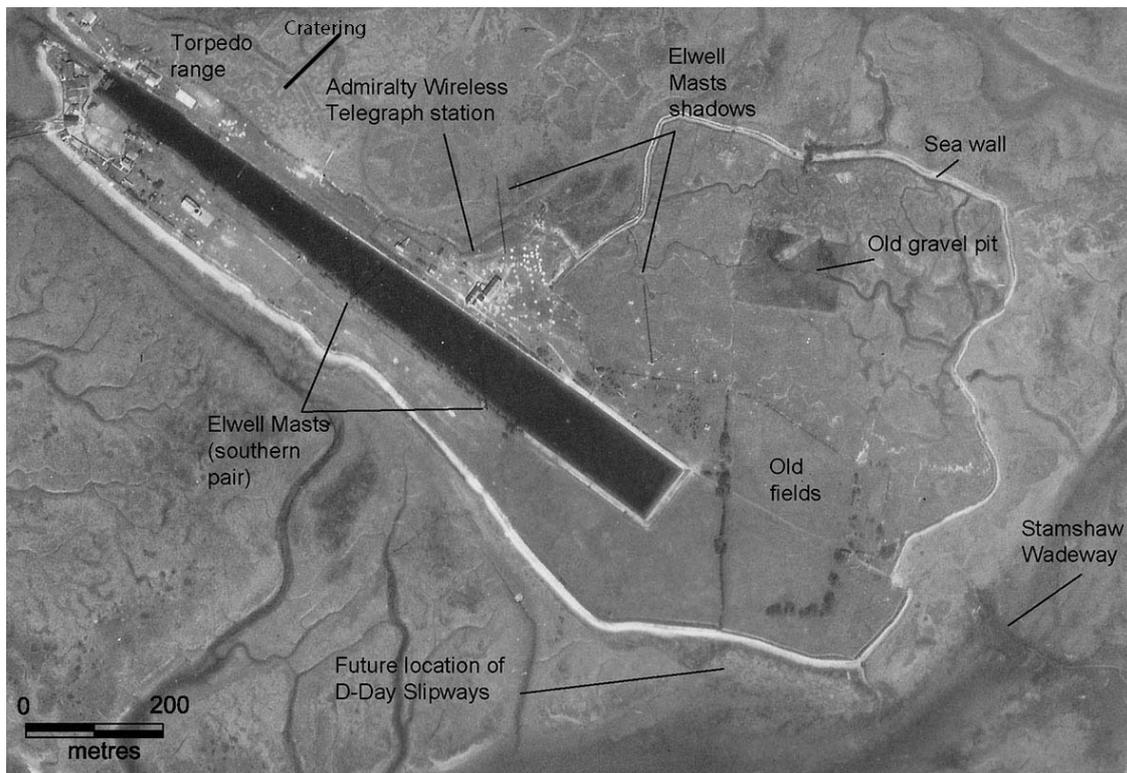
Figure 6: Extract of RAF vertical photograph showing an accumulation of pre-Second World War Naval installations and other features of Horsea Island. North is to the top. RAF/SOP/FV/61639 19-APR-1929. Historic England Archive RAF photography.

The earliest aerial photographs of the island are a set of good quality vertical images taken in 1929 by the RAF (Fig 6). These photographs show the island dominated by the (already obsolete) torpedo-testing pond and associated buildings from the various phases of naval use clustered around the north-western end. The four wooden Elwell masts of the second phase Admiralty W/T station can also be seen. Two masts cast shadows to the north of the pond and the southern two are just visible on the southern side, casting their shadows across the water. The control buildings were located on the northern edge of the torpedo pond close to the north-western mast. The positions of probable masts stays and additional mast arrays can be seen as a grid of white dots around the buildings of the wireless station. Three separate lines of white dots can be seen extending out from the base of the eastern mast, likely to be the tether points for the supporting stays of the mast.

Non-military features include the sea wall around the two amalgamated islands, the old gravel pit used to build and maintain the wadeways and traces of the Stamshaw wadeway extending south-east from the island.

There is a record of the marshland on the north-east side of Little Horsea being used for explosives testing in the 19th century (Ripley 1982, 11). Clusters of craters seen on the 1929 RAF aerial photographs between the Torpedo range and Wireless station on the north side of the torpedo range may be the remains of some of these explosions (Fig 6).

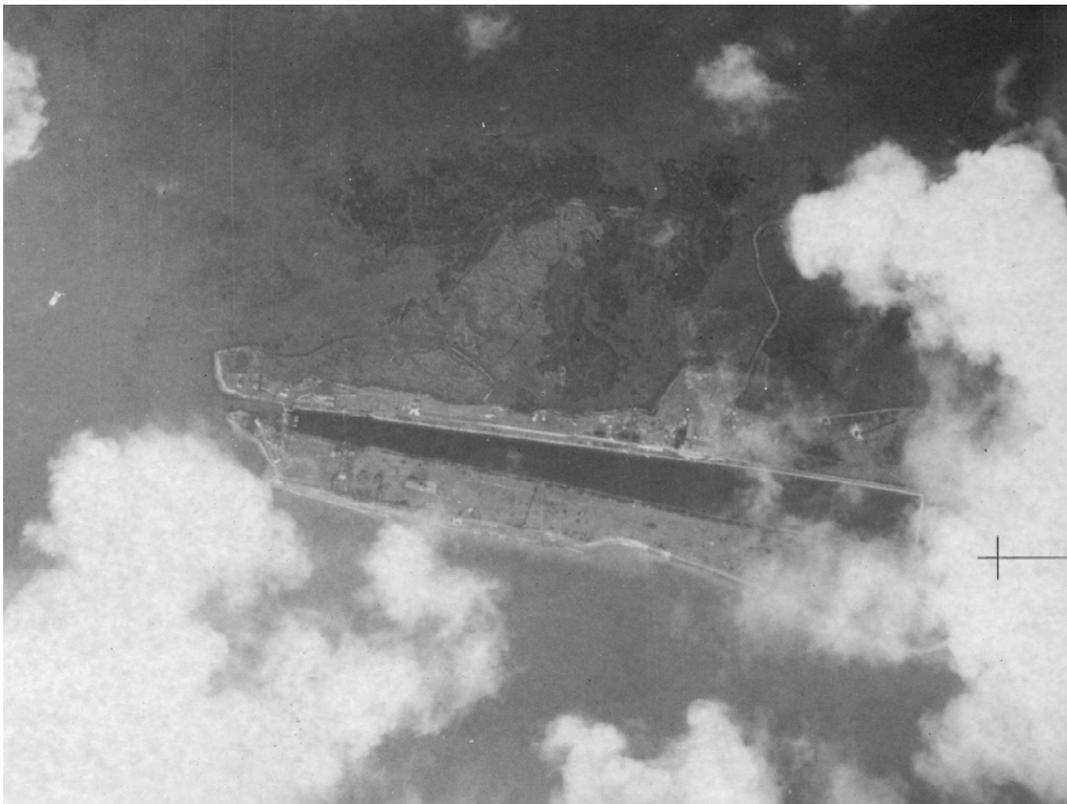
Figure 7: The north-west end of Horsea Island seen through cloud showing the torpedo pond. Extract of RAF/FNO13C 6265B/V/635 14-MAR-1941. Historic England Archive RAF photography.

Two sets of RAF aerial photographs were taken of the Portsmouth harbour area in 1941 and 1942 prior to the construction of the slipways (Figs 7 and 8). Both are high level and therefore small scale, making detail difficult to discern. Cloud also obscured the eastern half of Horsea Island on the 1941 aerial photographs and most of the island on the 1942 photographs. However, it is just possible to make out the south-eastern end of the island on the 1942 photographs where the pale circular embankments around three of the masts of the third phase of wireless station, which were installed in 1932-3, can be seen (Ripley 1982, 18).

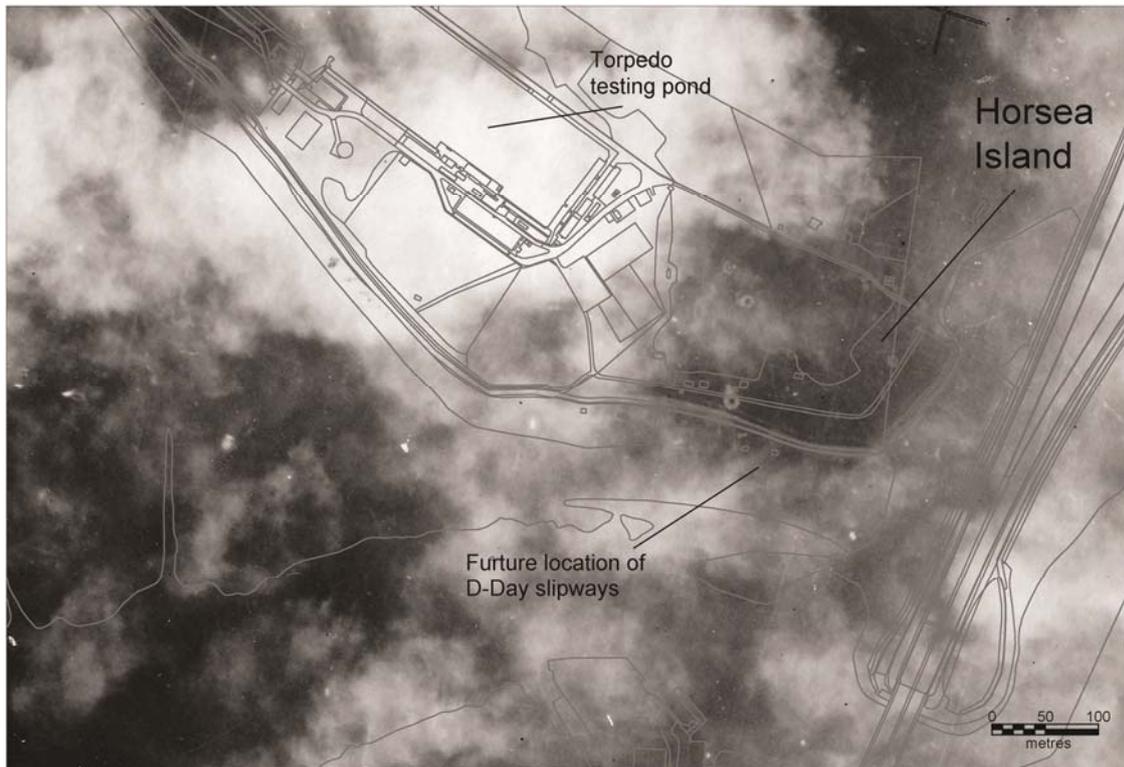
Figure 8: Aerial photograph of the southern end of Horsea Island, mostly obscured by cloud, overlain with modern mapping. The 1930s embankments associated with the wireless-station masts are just visible at the south-eastern tip of the island between the clouds. Extract of RAF aerial photograph RAF/FNO/13C/V/636 04-JUN-1942. Historic England Archive RAF photography. Base map © Crown Copyright and database right 2020. All rights reserved. Ordnance Survey Licence number 100019088.

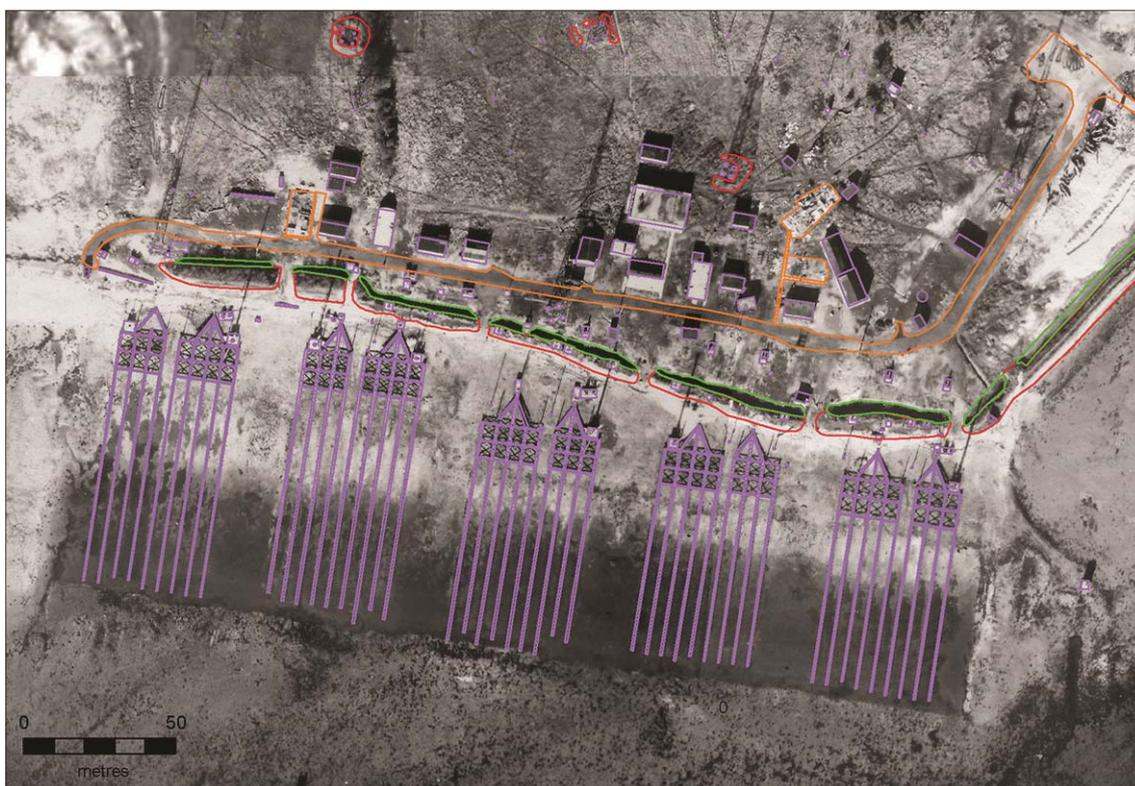
Figure 9: Aerial photograph overlain with mapping of key features of the slipways. Also see Fig 12 for detail. Purple = structure, red = bank, green = ditch and orange = extent of feature. Extract of RAF aerial photograph RAF/106G/UK/955/RVp3/6246 30-OCT-1945. Historic England Archive RAF photography.

The site at Horsea Island comprised five broadside slipways, by far the largest of these purpose-built landing craft maintenance yards. Though no contemporary description of the Horsea site has been found, they appear morphologically similar to the Devon sites, so are likely also to be Broadside slips. The slipways were constructed on the beach in the south-east corner of the island with a complex of workshops and yards set behind the existing embanked sea defences.

The five slipways were arranged along the shore, each consisting of a series of nine parallel ribs approximately 85m long and 0.5m wide, set between 4m and 4.5m apart. Each slipway had two platforms on which the landing craft were winched out of the water to be serviced. These pairs of platforms were unequal in size due to the odd number of ribs making up each slipway (one platform sitting across five ribs and the other across four, separated by the gap between the ribs). The platforms had an open framework with a lattice or meshed infill which can be seen on aerial photographs to cast a shadow on the beach below (Figs 9 and 12). Each platform had a triangular frame extending up the beach, and one or two square concrete blocks at one or both of the landward corners with a central post. These were set on concrete bases measuring about 4m square, most of which still remain today.

A low bank, probably the remains of the former sea wall, separated the beach from the maintenance yard. This had a number of causeways aligned with the gaps between each slipway, presumably for access. Set into this bank were a number of concrete blocks measuring 2.5m square with a central bollard for tethering and winching the ships onto the slipway.

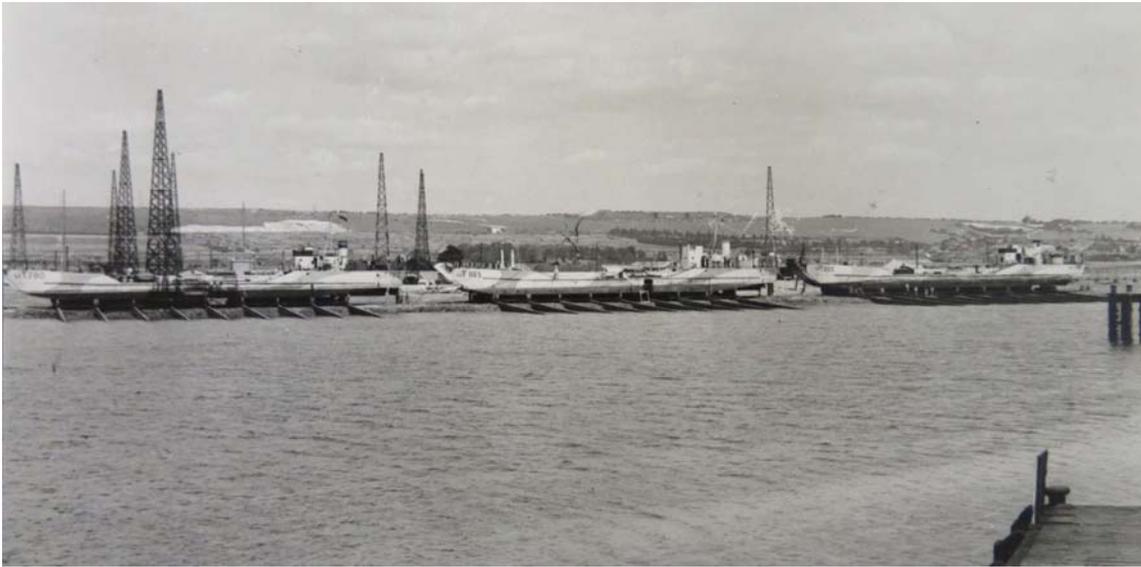
Figure 10: Horsea Island slipways with three landing craft (LCT889, LCT 1165 and LCT 790) in place, probably receiving running-repairs following D-Day. Photograph title: 'Horsea Island – view of slipways at low tide looking north-east 12th June 1944' ADM 1/17813 P.248/44 © National Archives. Reproduced with the permission of the National Archives, Kew

Over 800 LCTs took part in Operation Overlord. Each LCT was capable of carrying 10 tanks or other heavy armoured vehicles, and troops (National Museum of the Royal Navy 2020). Following the initial offensive, a continual supply chain of craft was established from ports along the south coast to maintain the Allied forces through the beachheads at Normandy. These ships were frequently under attack in transit, and many were lost or severely damaged. Throughout this period vessels returned to the established maintenance yards such as Horsea for running repairs. Photographs held by the National Archives, Kew show the Horsea Island slipways on 12 June 1944, six days after D-Day and the start of Operation Neptune with three such returned landing craft (LCT889, LCT 1165 and LCT 790) in position on the slipways, probably for repairs (Fig 10).

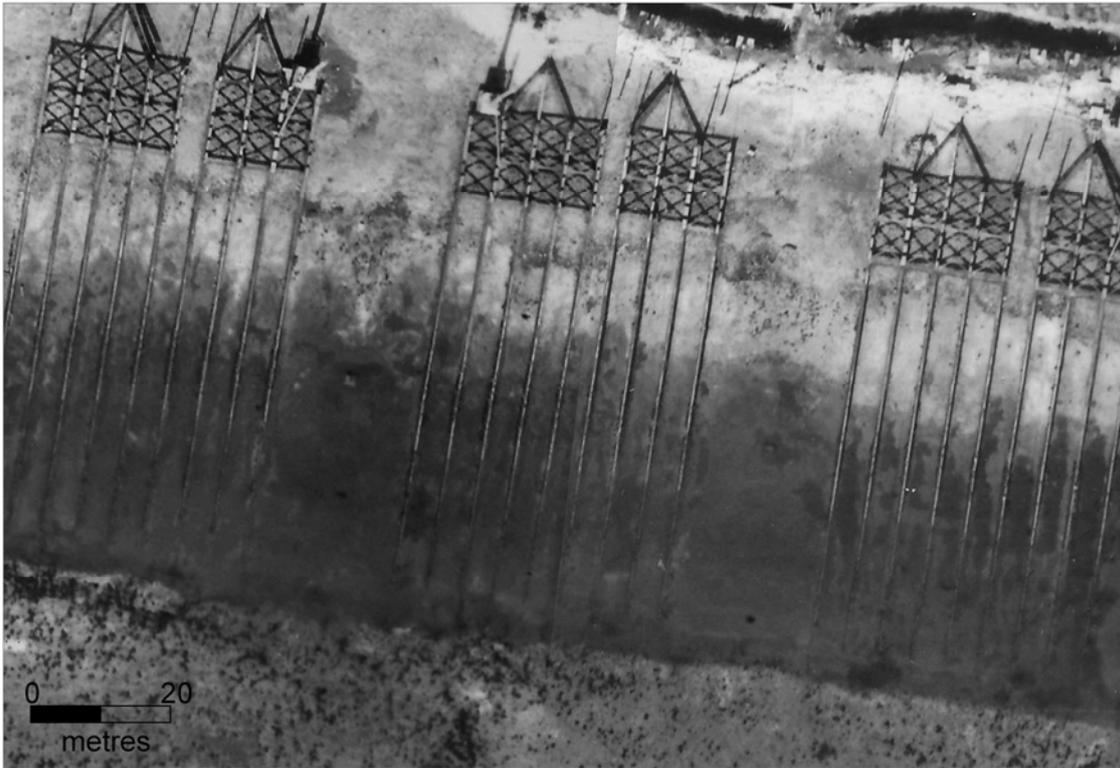
Figure 11: Extract of RAF aerial photograph RAF/106G/UK/955/RVp3/6246 30-OCT-1945 showing detail of the slipways with the raised trellis or platform with the possible winch housing and tether points at the top of the beach. Historic England Archive RAF photography.

RAF aerial photographs taken in October 1945 (Fig 12) and April 1946 (Fig 13) record the repair yard just after the end of the war. The site was abandoned (presumably decommissioned or mothballed) by this time, but appears intact and is still littered with discarded construction materials such as piles of timber and large loops, probably coils of salvaged winch cable (Fig 13). There are no vehicles present and portable items such as generators and oil drums seen on the ground photographs have been removed. On aerial photographs taken in April 1946 the site still looks churned up with exposed chalk and worn paths between buildings from the intensive pre-D-Day activity, and much of the debris seen in the previous October is still in evidence across the site, but the moving platforms have been removed from the slipways leaving the ribs exposed.

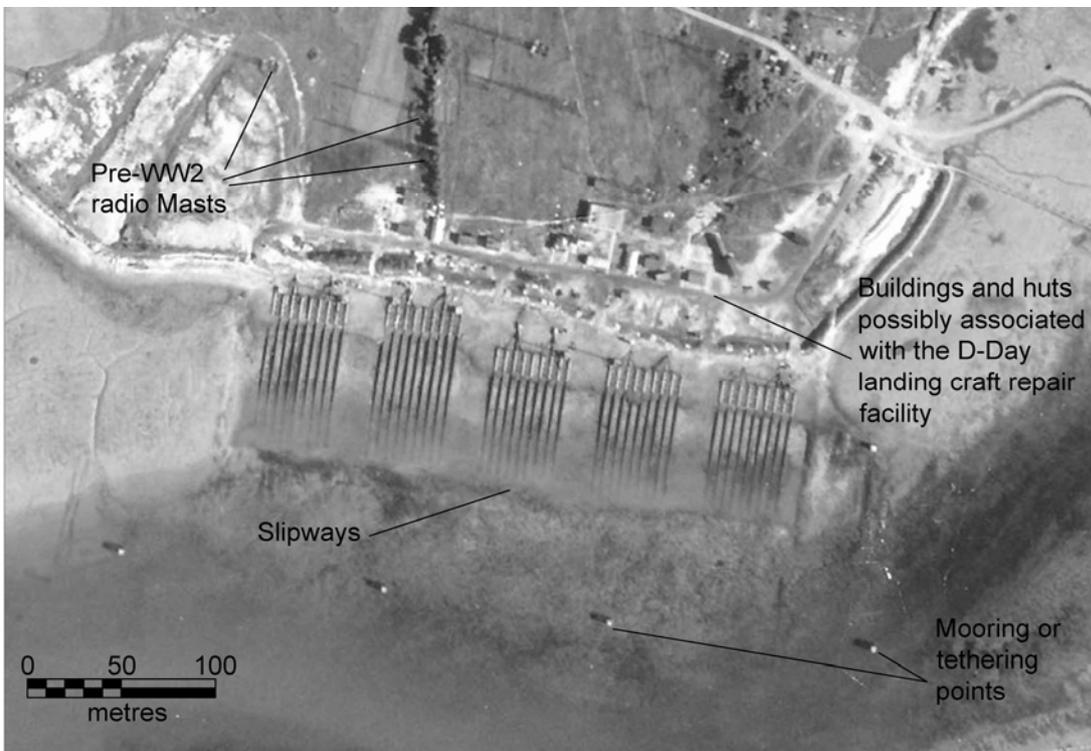
Figure 12: The slipways and associated features in 1946. Extract of RAF/3G/TUD/UK/156/V/5008 19-APR-1946. Historic England Archive RAF photography.

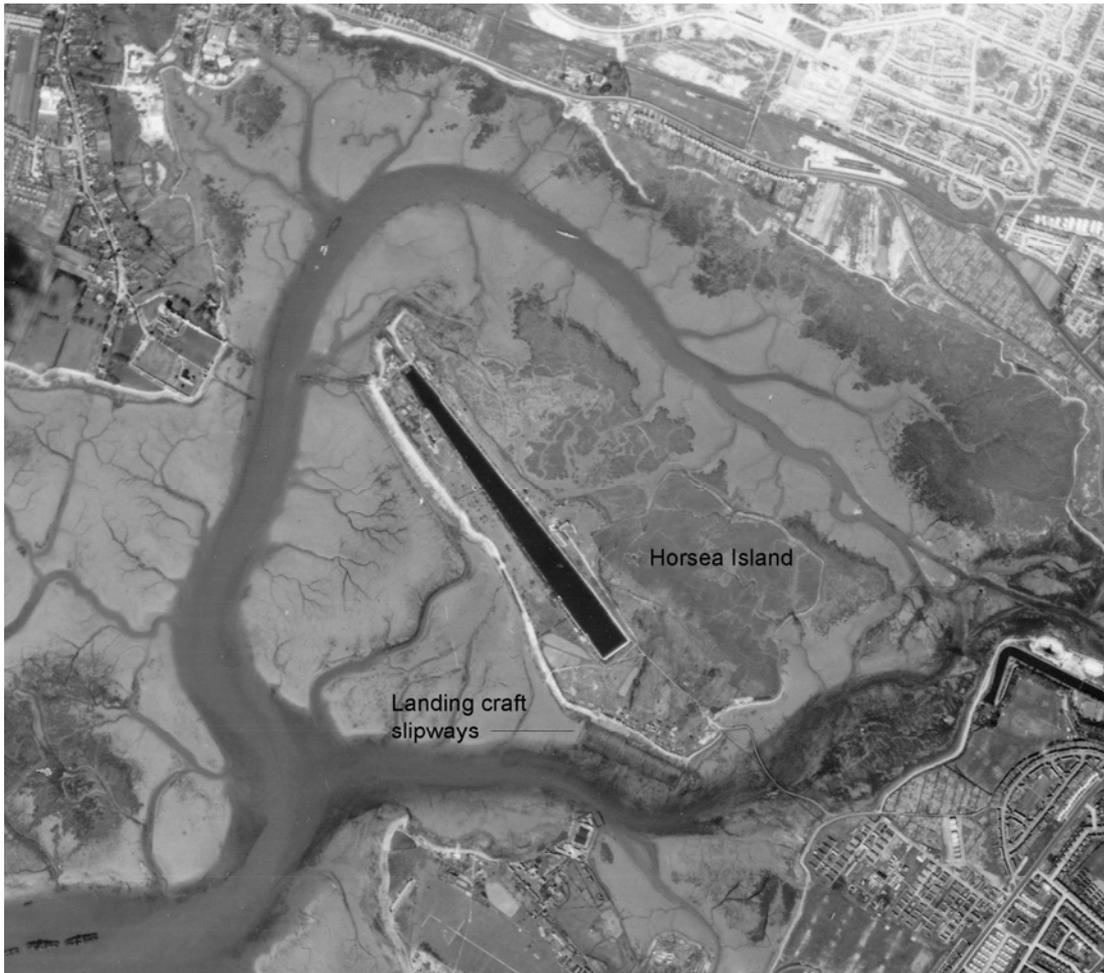
Figure 14: High-level vertical aerial photograph showing Horsea Island at low tide with the slipways visible on the bottom end of the island. Extract of RAF/540/177/5075 09-APR-1949. Historic England Archive RAF photography.

The site appears again on high-level RAF vertical photographs taken in April 1949 (Fig 14). The buildings appear to be extant, but the scale of the photographs make discerning any details of the state of the remaining facilities difficult.

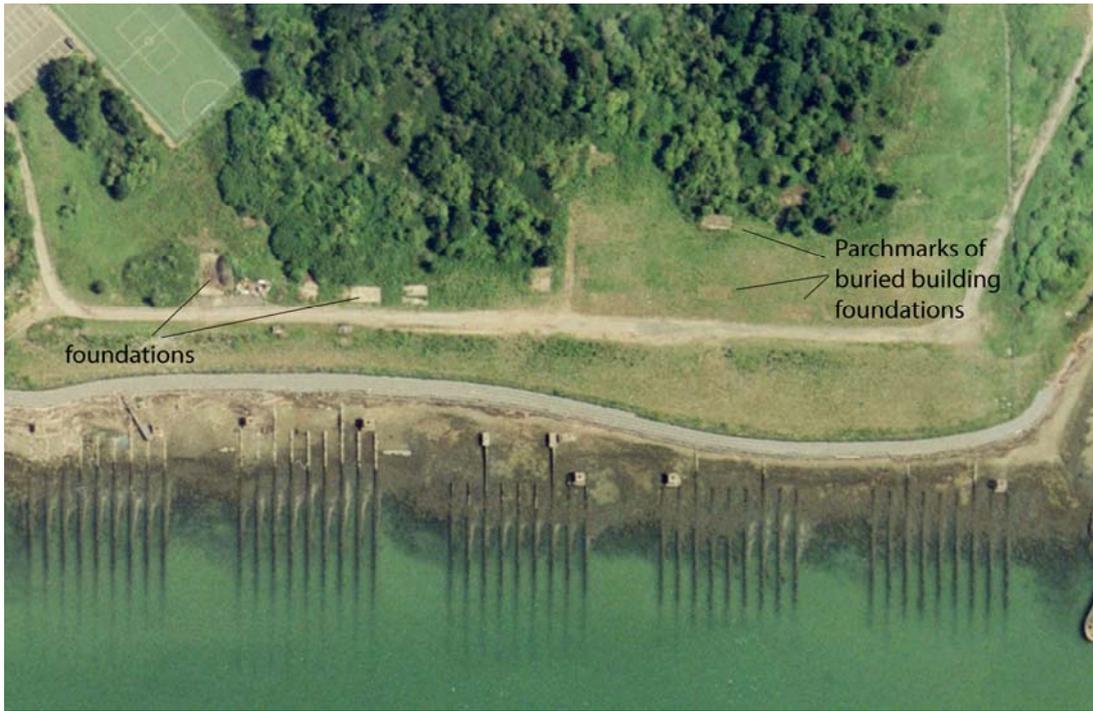
Figure 15: Extract of Google Earth aerial photograph dated 01-JAN-1999 (though vegetation suggests a summer date) showing surviving steel and concrete remains of the D-Day slipways. It also shows the remains of the concrete hut bases and parchmarks of further buried foundations, hard-standings and roads of the Second World War maintenance yard located above the beach on Horsea Island. EARTH.GOOGLE.COM ACCESSED 04-FEB-2020.

After the Second World War there was considerable reclamation, infilling and development of Horsea Island, eventually joining it to the mainland. However, the torpedo testing pond has survived and the south-eastern corner has remained relatively untouched. 1999 Google Earth aerial photographs (Fig 15) reveal the continued presence of the slipway ribs and some of the associated concrete structures on the beach. A service road follows the course of the wartime access road through the maintenance yard, but the rest of the depot site has not been developed and is now overgrown with vegetation. The remains of some of the Second World War maintenance yard buildings survive at foundation level in the vegetation above beach. There are several rectangular concrete hut bases and paths or roadways in the western half of the depot site on the northern side of a later service road. Parchmarks of buried foundations relating to the site are clearly visible in the grass in the eastern half of the site. Aerial photographs taken in 2017 show the continued presence of the Second World War buildings surviving as buried or semi-buried foundations (Fig 16). They also show the slipways at low tide, with between 20m and 30m of their seaward ends covered with marine silt.

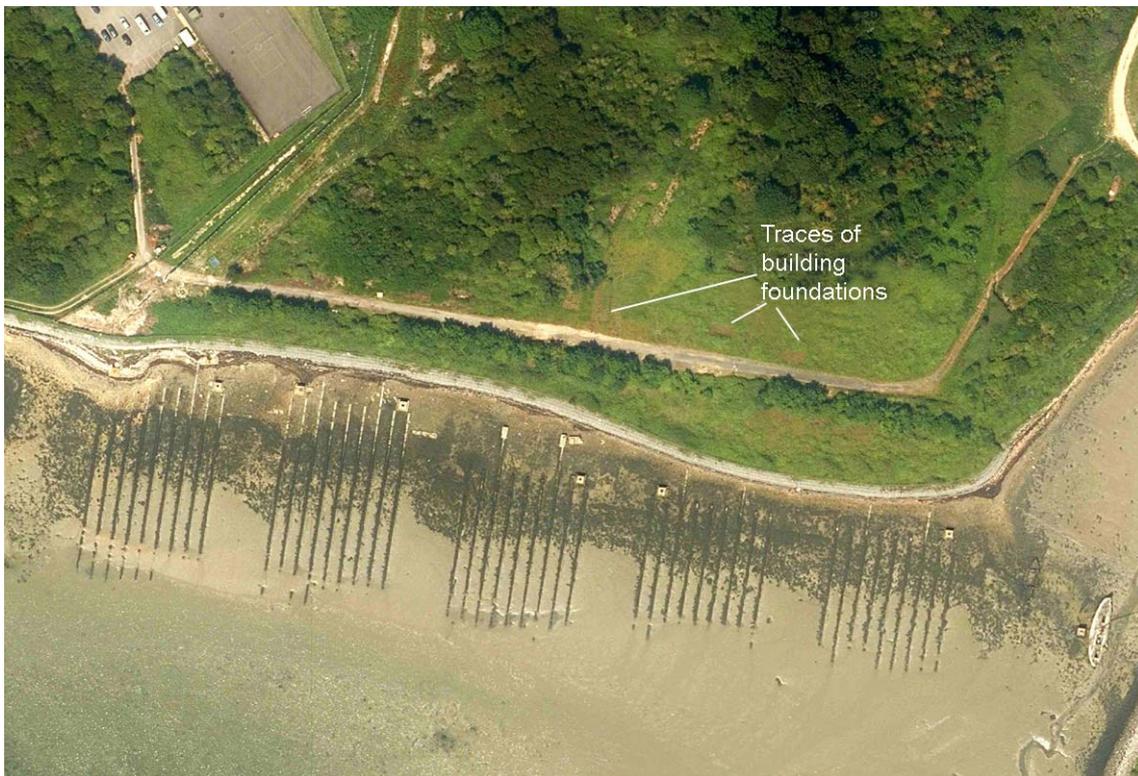
Figure 16: Extract of APGB mosaic aerial photographs taken in 2017 showing the slipways partially covered by silt and the sites of former Second World War buildings above the beach. 21-JUN-2017 ©Bluesky International/Getmapping.

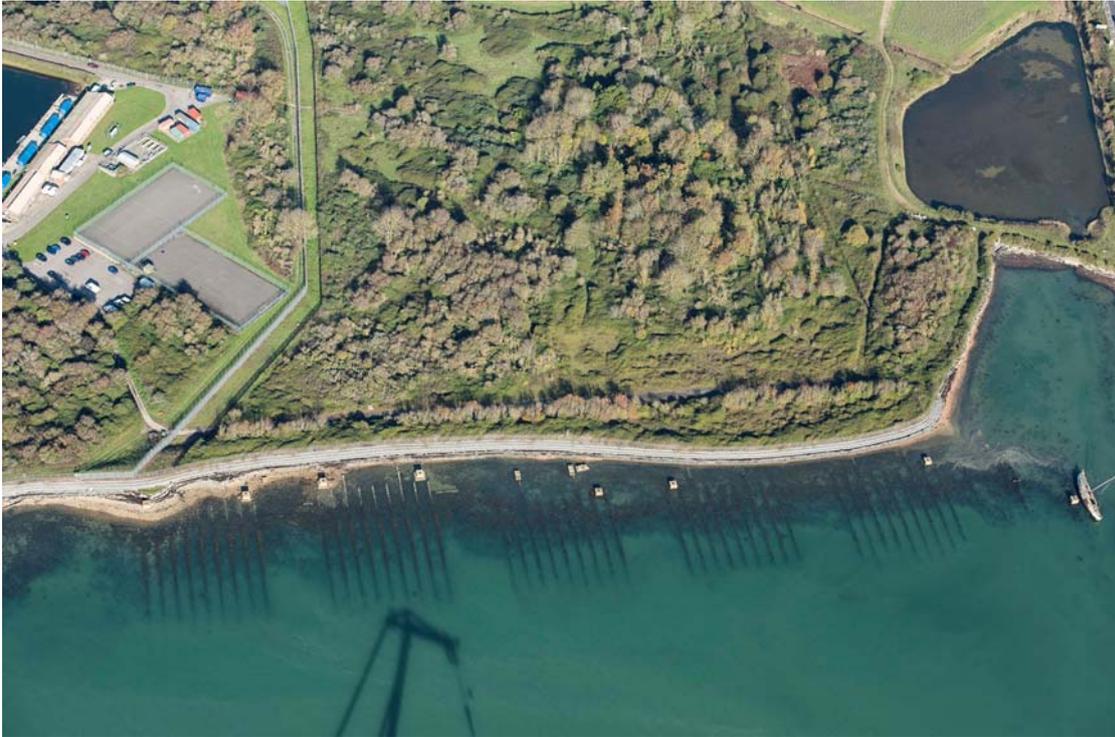
Figure 17: The slipways, partially submerged, taken in November 2020 by Historic England. The vegetation inland of the beach appears matured since photographs taken in 2017. HEA 33943\_022 04-NOV-2020 © Historic England Archive.

The most recent photographs taken in November 2020 by Historic England show the site unchanged, but the vegetation behind the beach more mature and traces of building foundations obscured (Fig 17).

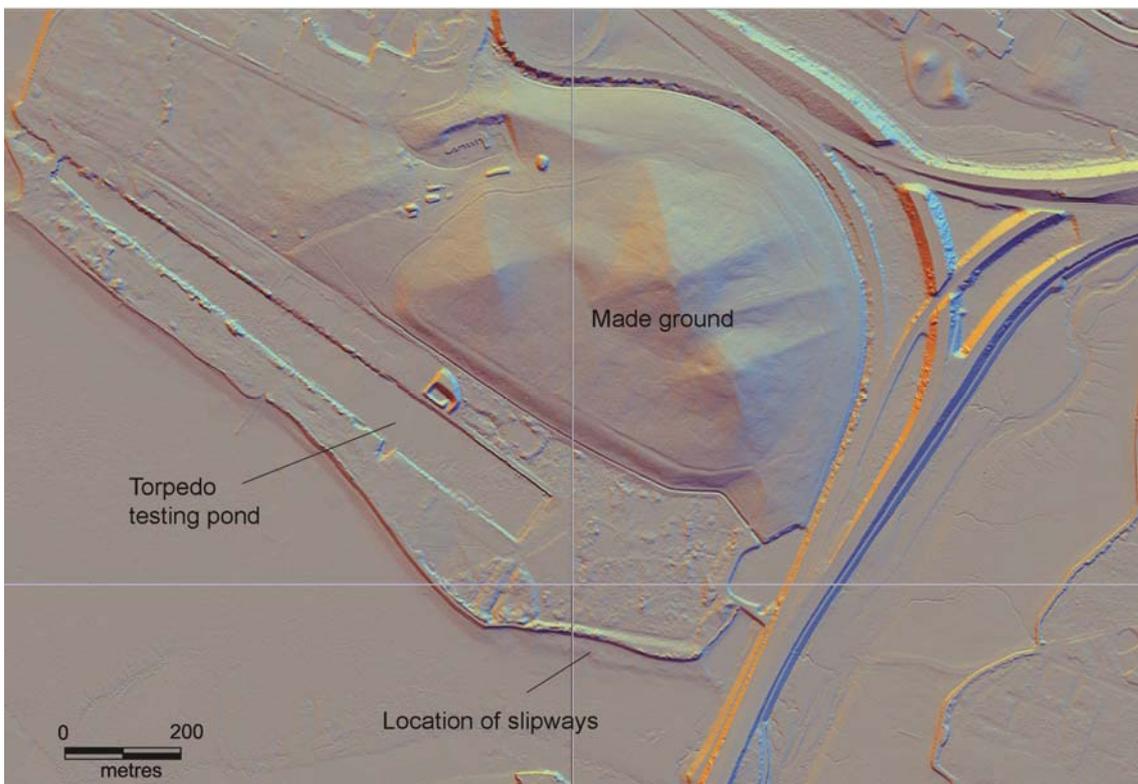
Figure 18: Extract of processed lidar data for Horsea Island and surrounding area highlighting the torpedo pond and a large area of made ground to the north. LIDAR (SU6303, 6304, 6403 and 6404). © Historic England; source Environment Agency.

The evidence from maps, aerial photographs and lidar suggests much of the original island has been altered and enlarged, perhaps with the exception of the south-east facing edge (Figs 18 and 19). It is thought that there was reuse of debris from earlier bomb damage elsewhere on the island incorporated into the D-Day landing craft maintenance yard (Ripley 1982, 18).
